## **Morphodynamics of Coastal Lagoons: An Analysis of Multitemporal Landsat Images of Segara Anakan Lagoon Area**

### **ABSTRACT**

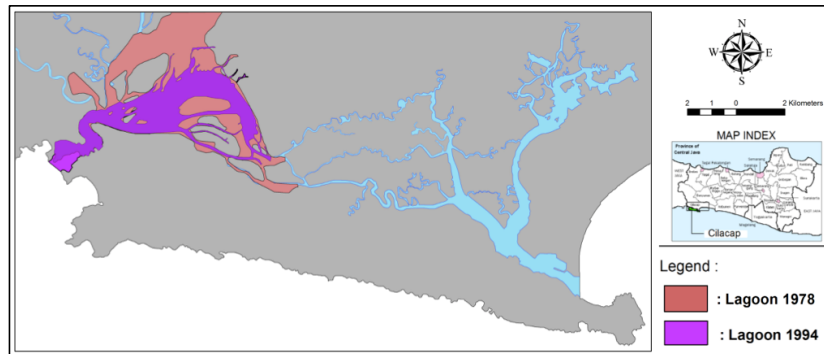
Figure 1. Changes to the lagoon's morphology (1978-1994)

Figure 1 shows how the area of the lagoon changed from 1978 to 1994. This was a first phase of changing area at the lagoon. In 1978, the area of SAL was 4665 hectares, which was reduced dramatically to merely 1758 hectares in 1994. In other words, over 16 years, there was a loss of 2907 hectares. At that time, the first settlement was also built by farmer immigrants from the main land such as Java and Sumatera islands (Ardli & Wolff, 2009). Moreover, during that time, the area of accretion also increased significantly due to sedimentation transport from the upland watersheds. The area of land accretion in 1978 was 49 hectares, which increased by 170 hectares in 1994 to 219 hectares. This means that the increase in land accretions per year over that period was approximately 10.63 ha.

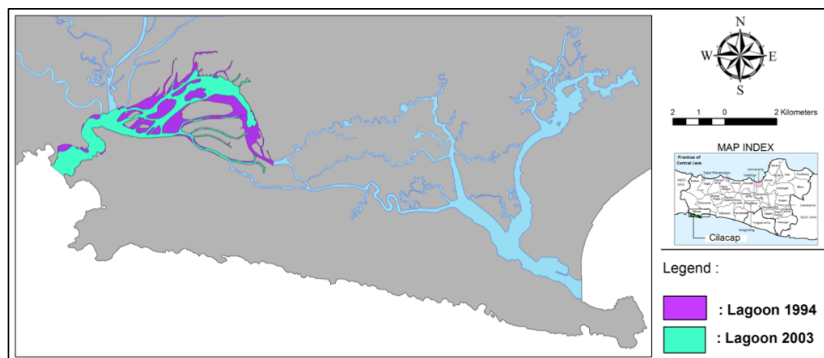
Figure 2. Changes to the lagoon's morphology (1994-2003)

Figure 2 shows changes in the lagoon morphology from 1994 to 2003. The area of SAL did not only change in 1994, but also in 2003, with additional land accretion of approximately 39 hectares. The total area of SAL in 2003 was 991 hectares, which means that over a period of nine years, another 767 hectares were lost from the lagoon. The main cause is the high rate of sedimentation of the Citanduy River, which carries more than 9 million tons  $m^3$  per year of sedimentation matter. Over this same period, an additional resettlement complex has also more than 2000 ha established. This further accelerated the process of environmental degradation in SA. Not only settled but also they stated the management of rice farming, which was running quite successful with the technical assistance provided by community organisation.

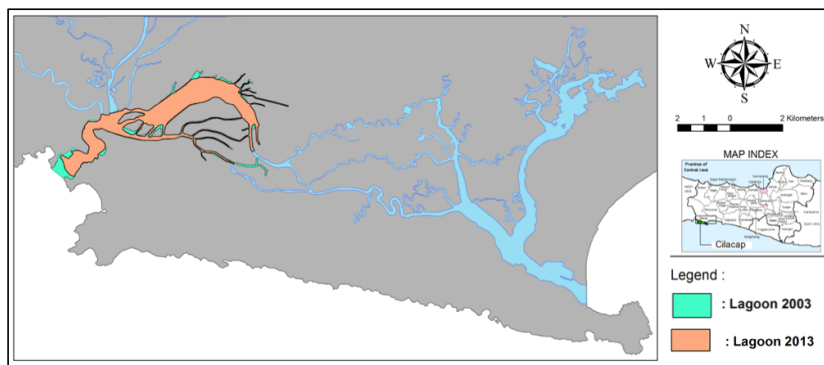
Figure 3. Changes to the lagoon's morphology (2003-2013)

Likewise, Figure 3 shows the changes to the lagoon's morphology from 2003 to 2013. In 2013, the SA area was reduced from 644 hectares to 347 only hectares, with additional 579 hectares of accreted land, reflecting that over ten years, the lagoon became narrow with an increase in the accreted land of 57.9 ha/year. It was clear that the extensive lagoon would diminish with a tendency to disappear in the coming year, covered by the sediment. However, the main factor has also increased at that time, i.e. illegal logging of mangrove in this region (Jennerjahn & Yuwono, 2009).

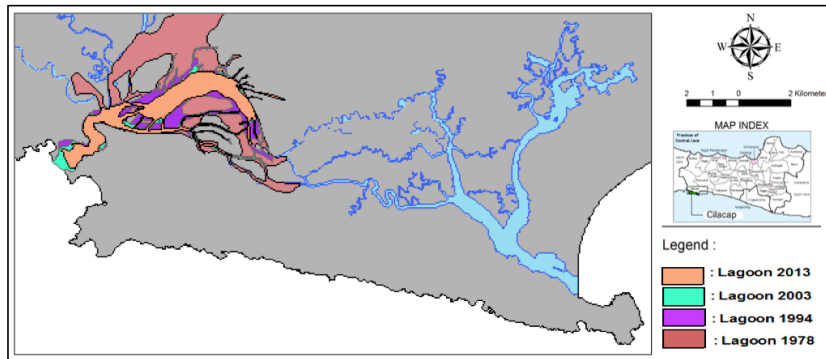
Figure 4. Changes to the lagoon's morphology (1978-2013)

Figure 4 shows the overall changes of the lagoon due to sedimentation and accretion. From 1973 (the first phase of changes), the lagoon area was still in natural condition, i.e. there was not disturbing factor that caused area of the lagoon to shrink. In the second phase (1994), the area of lagoon tended to decrease as an effect of natural phenomenon such as the eruption of Galunggung Mountain volcanic in 1982.

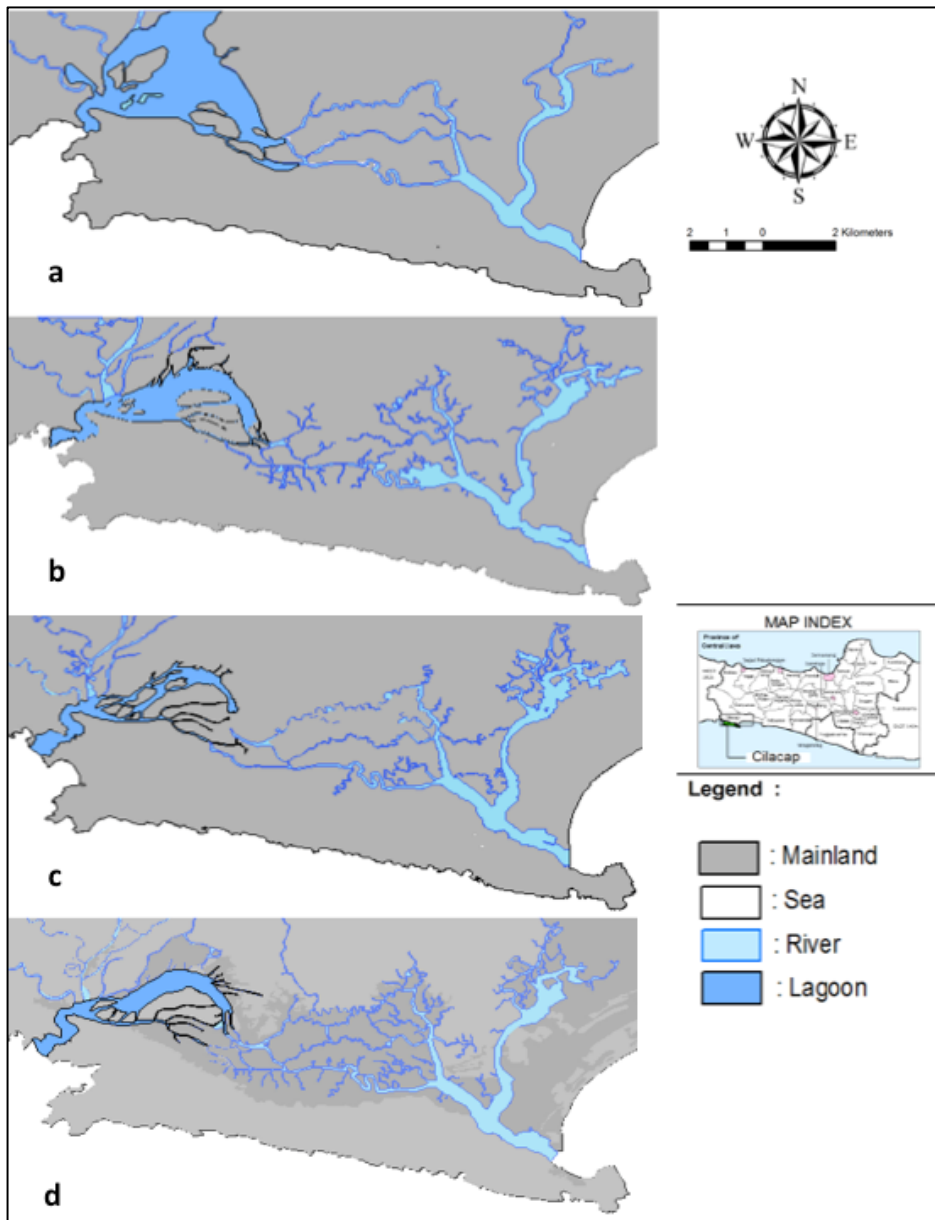
Figure 5 shows the shrinkage of the water area in SAL. It can be seen that those changes from the emergence of new land or an increase in the extent of land that had previously been in the lagoon, as well as a reduction in the water area of the SAL.

Figure 5. Changes to Segara Anakan lagoon's morphodynamics since 1978 (a-d)  
(Source: MSS, TM, ETM and Landsat 8 images map, System coordinate WGS 1984 zone 49s; author's own results)

Based on the morphological comparisons of SAL from the Landsat image interpretations in 1978, 1994, 2003, and 2013 (see Figure 5 and Table 1), it can be clearly seen that the morphological changes of the lagoon have occurred in the western part of the lagoon. The area of the lagoon narrowed due to intensive sedimentation from the river Citanduy that will eventually create a lagoon in the future.

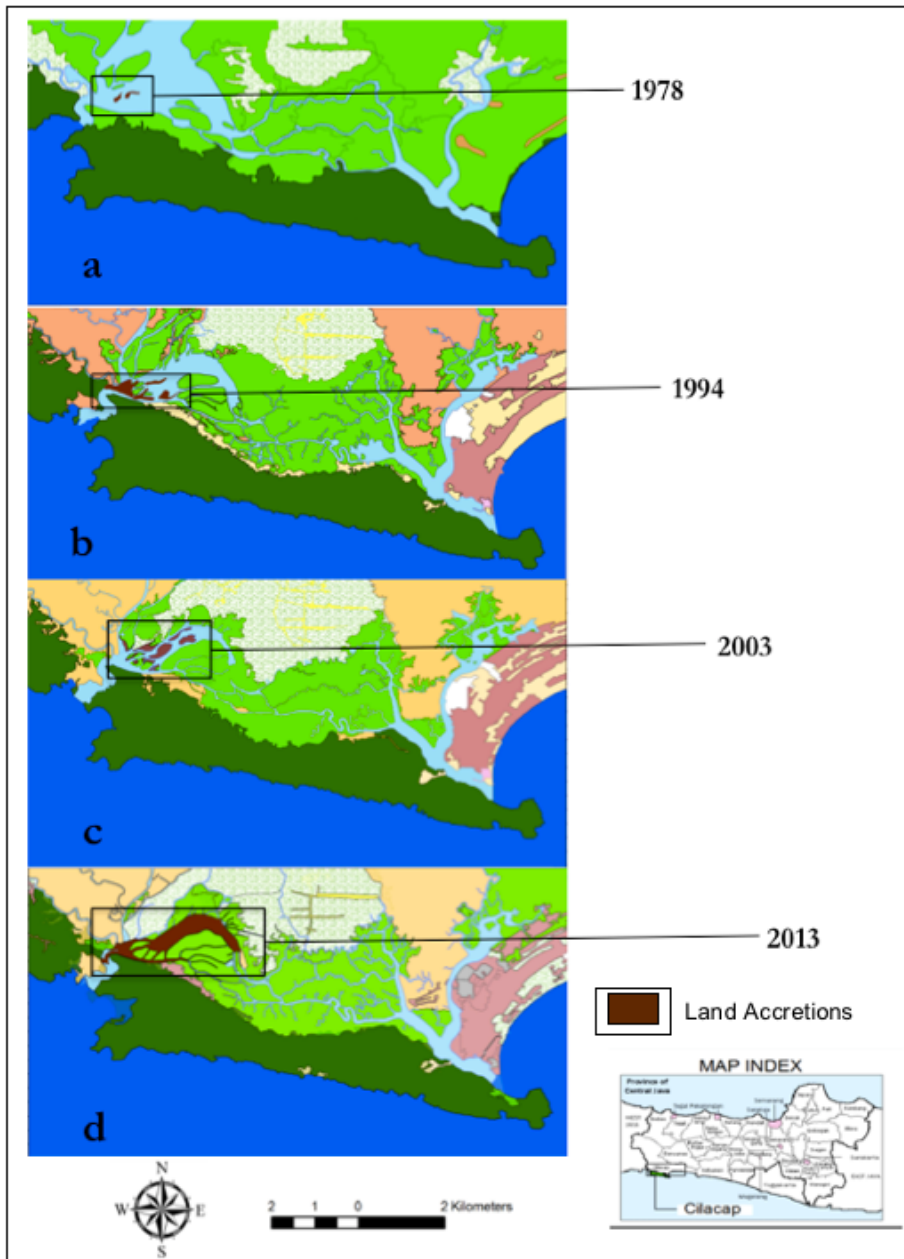
The shrinkage of the water area of SAL can be seen in Figure 6, which shows that the emergence of land accretions occurred in the middle, western and northern parts of the lagoon. The shrinkage of the water area of SAL is strongly associated with the occurrence of erosion and sedimentation.

Figure 6. The development of land accretions in the Segara Anakan Lagoon since 1978 (a-d) (Source: MSS, TM, ETM and Landsat 8 images map, system coordinates WGS 1984 zone 49s; author's own results)

In addition to the reduction in the area of water found in the SAL, there has also been an additional area of land accretion as shown in Figure 6, which illustrates the extent of the area from land accretion in 1978 (Part a). Meanwhile, Part b shows the changes to the area of the SAL and the increase in the area for land accretion in 1994. Likewise, parts c and d show the changes in the land accretion area in 2003 and 2013. Hence, over a 35-year period, there has been an increase in the area of land accretion, covering 788 hectares, with the growth of land accretion at approximately 22.5 ha/year as a result of sedimentation.

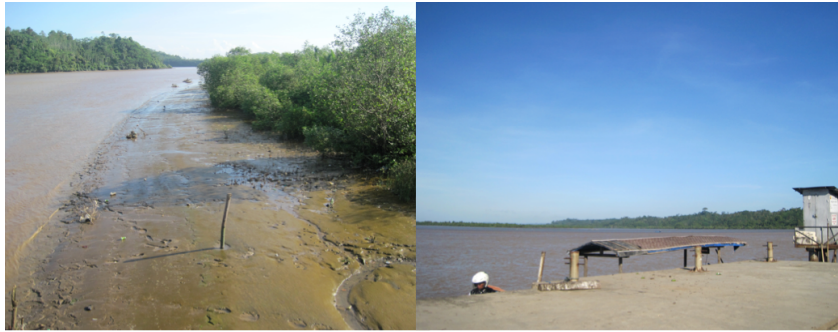
Figure 7. Sedimentation matter brought from Citanduy River

Figure 7 shows that the materials deposited into the SAL consisted of clay, silt and sand. Sediment from Citanduy River contributed to more or less 9,000,000 tons  $m^3$ /year. Citanduy River located in Western Java, where it flows through two provinces of West Java and East Jawa through Ciamis Regency and Cilacap Regency.

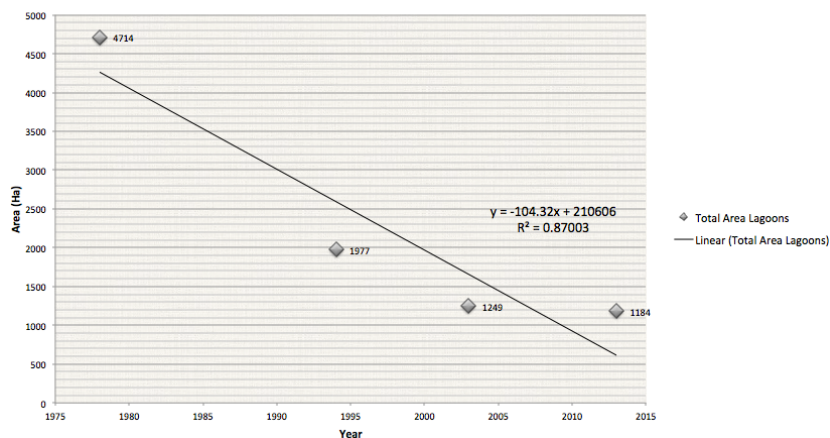
Figure 8. The formula used for the linear regression of the total area of Segara Anakan Lagoon, 1978-2013 (Source: Author's own results, 2015)

Figure 8 is the formula used for the linear regression of the total area of Segara Anakan Lagoon in 1978-2013. It shows how much of a change there is between the beginning of the trendline and the end. Regression lines also give us useful information about the data they were collected from. They show how one variable changes on average with another. For instance, the trends of the area decreased during the development of lagoon, but on the other hands, the area of land accretion was significantly increased.

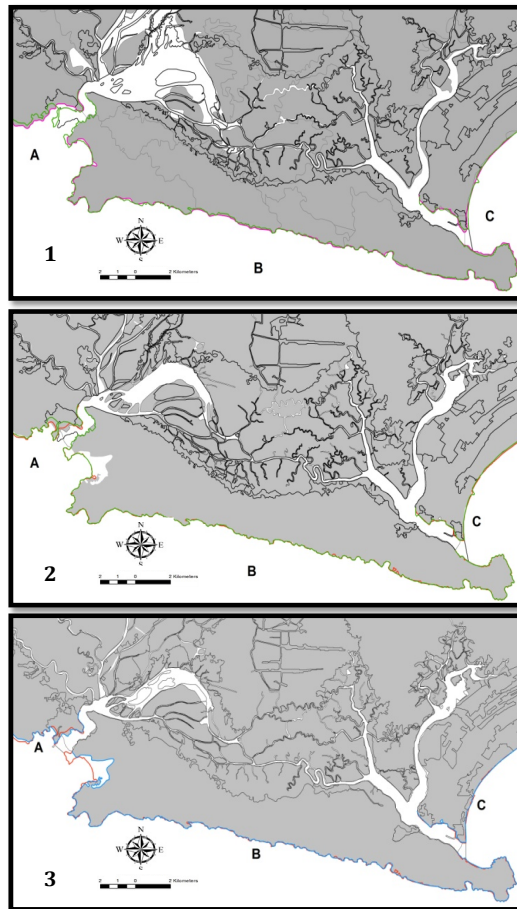
Figure 9. Coastline Changes from 1978-2013: (A) West channel, (B) Nusakambangan, and (C) East Channel (Source: MSS, TM, ETM and Landsat 8 images map, system coordinates WGS 1984 zone 49s; author's own results)

Besides the effects of sedimentation processes that were taking place in the SA water body, the abrasion process also influenced morphological changes to the SAL. The abrasion process taking place had impacts on the shape and coastline in the western part of the SAL (The comparison of coastline changes from 1978 to 2013 can be seen in Figure 9).

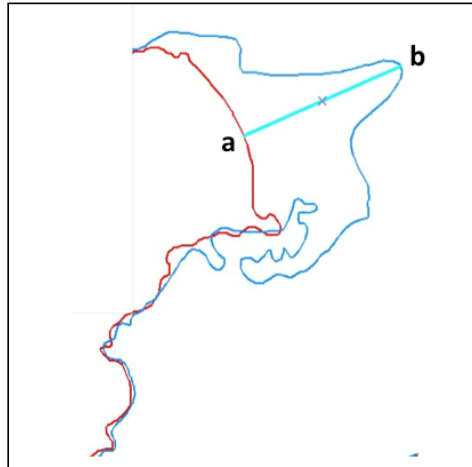
*Figure 10.* Coastlines changes 1978-2013 in the West Channel (A) sample area  
(Source: Author's own results, 2014; after MSS, TM, ETM and Landsat 8 images map, System coordinates WGS 1984 zone 49s)

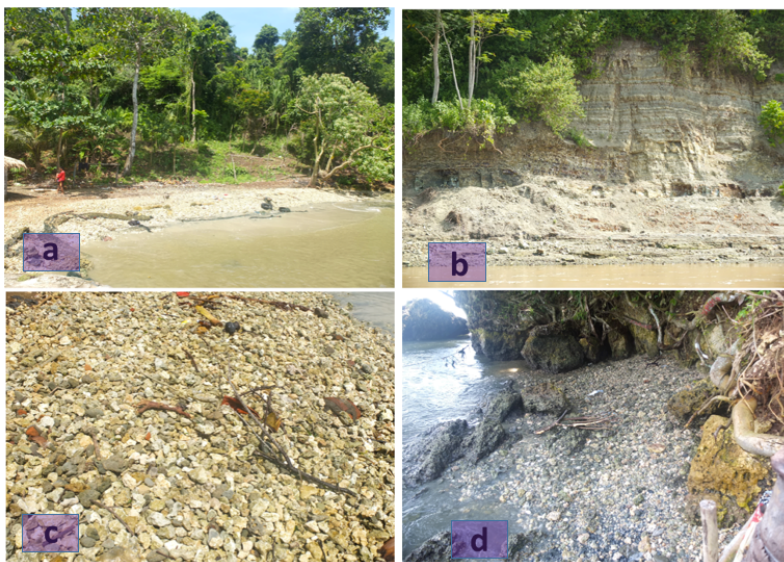
*Figure 11.* Geomorphological processes in Segara Anakan Lagoon  
(Photo: Author's, 2013)

Figure 11 shows the abrasion, erosion, and deposition processes in the area of investigation. Based on the observation and analysis of type of rocks, it could be described that: (a) Alluvial plains, found on the northern coast; (b) Erosion in the river valleys in the southern part of Nusa Kambangan Island, which consists of mud, sand, gravel and clay results deposition of broken breccia stone; (c-d). Deposition of limestone and marl in the Northern and Southern Coast of Segara Anakan.
