## Evaluating the Surrounding Physical Habitat for *Thynnichthys thynnoides*'s Spawning Areas using a Visual-Based Habitat Assessment at Rui River, Perak

This study was conducted to evaluate the physical habitat of spawning areas for *Thynnichthys thynnoides* (*T. thynnoides*) in the Rui River, Gerik, Perak. Five sampling sites of Rui River's floodplain were chosen. Sampling was conducted between May and October 2015 by using a visual-based habitat assessment developed for Rapid Bioassessment Protocols for Use in Streams and Wadeable Rivers: Periphyton, Benthic Macroinvertebrates and Fish. This study showed that *T. thynnoides* still migrated to the upper stream of Rui River during spawning season mainly in August. Habitat assessment scoring indicated that the physical habitat structure of Rui River fell into a suboptimal category, which was most likely able to support fish populations and thus providing a suitable habitat for *T. thynnoides* during the spawning season. Conclusively, it was observed that the *T. thynnoides* population was dependent on environmental conditions.

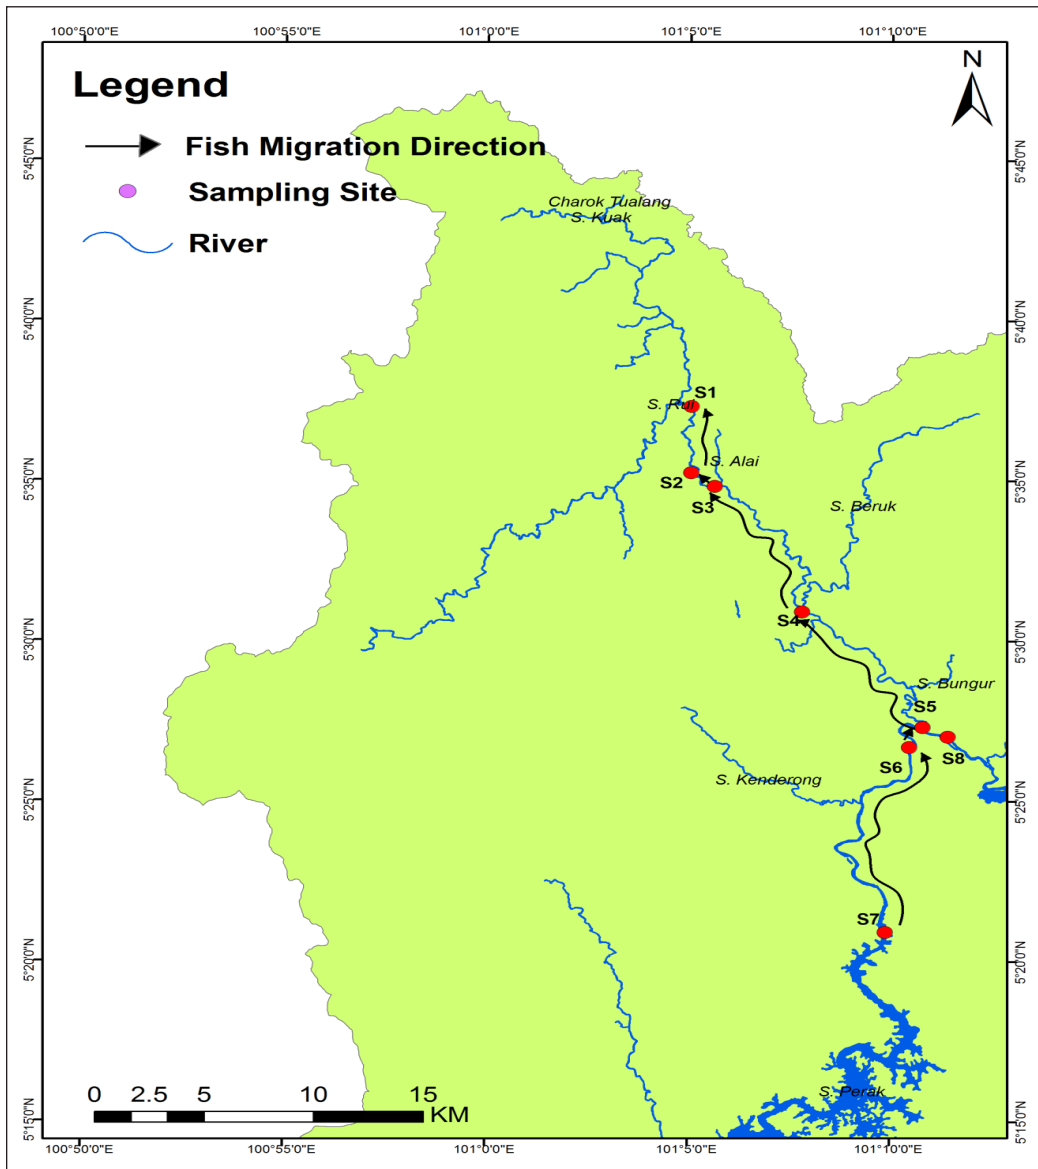
Figure 2. Migration movement of *Thynnichthys thynnoides* towards spawning areas during spawning season (May to October 2015). Spawning areas are predicted at S2 and S3 as no migration was observed at S1 during spawning season

The primary data collection was conducted from May 2015 to October 2015. The selection of five sampling points (from S1 to S5) for this assessment was based on the spawning areas of *T. thynnoides* (N = 5 sampling points × 3 replicates × 3 observers = 45 samples/river). The location of this fish in May 2015 was believed to be further downstream of Perak River, and the fish were spotted moving upstream from S7 and S8 to S5 in August (Mohamad Radhi, 2017). In September and October 2015, *T. thynnoides* started to migrate further to the upper stream of the Rui River at S2 and S3 (Figure 2).

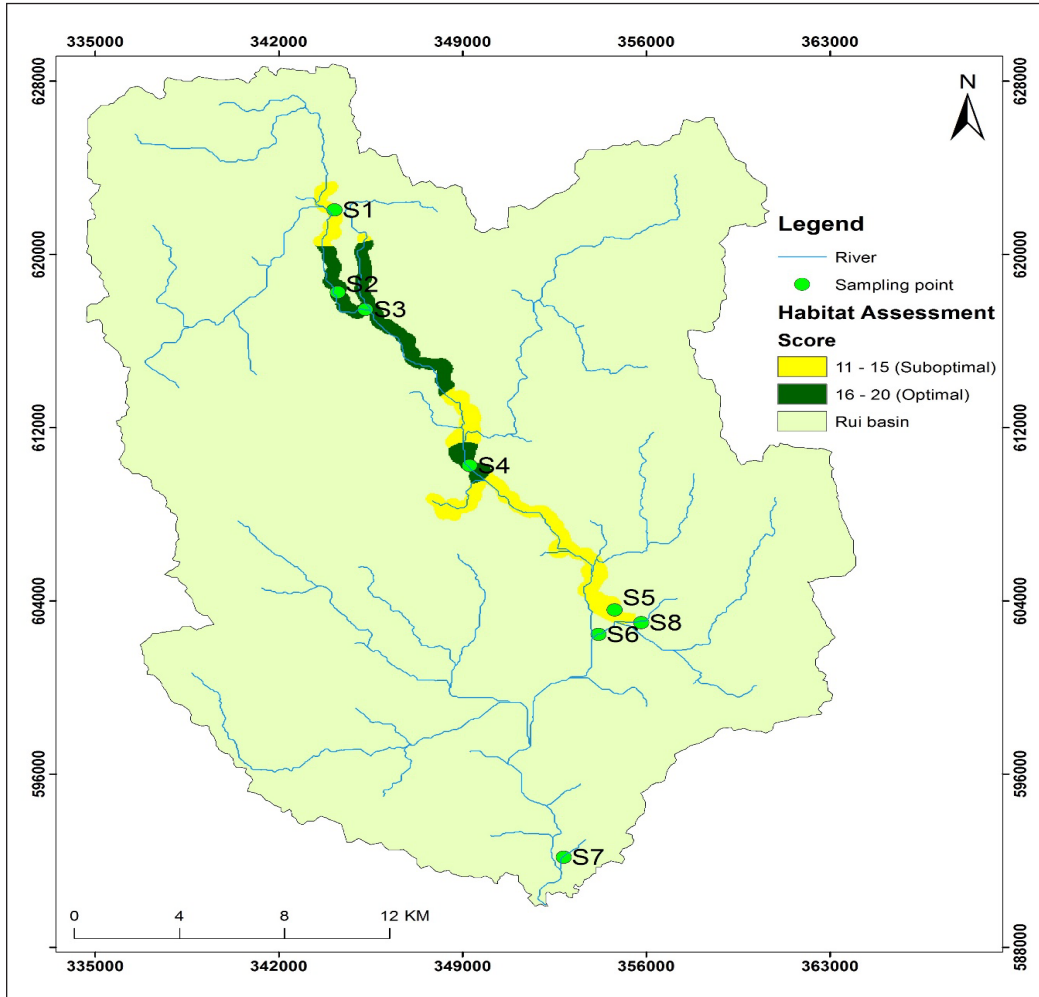
Figure 3. Digitized habitat assessment classification at the Rui River, Gerik, Perak

This sampling point was an area of local housing and oil palm plantation within the riparian zone (Figure 3).
